UI Bulletin #140d

Subject: UV Protective covers on Fuel Tanks Components

Models Affected: Chevrolet Colorado/GMC Canyon with box delete (ZW9)
Chevrolet Express/GMC Savana Cut–away vans
Chevrolet Silverado/GMC Sierra with box delete (ZW9) and Chassis Cab Models

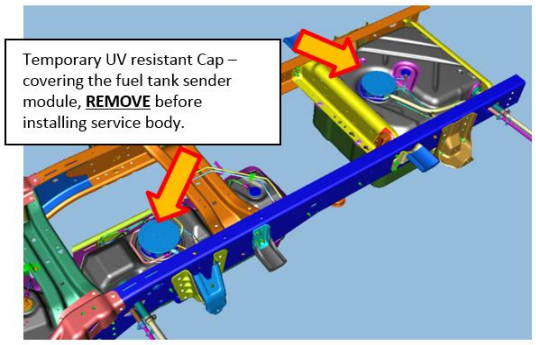
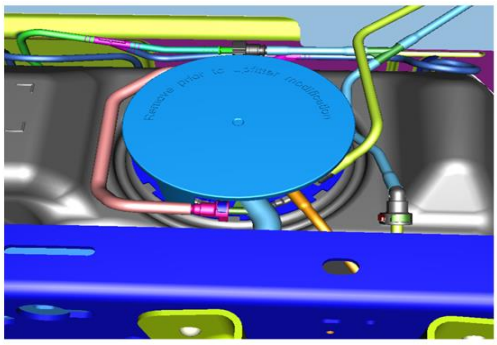
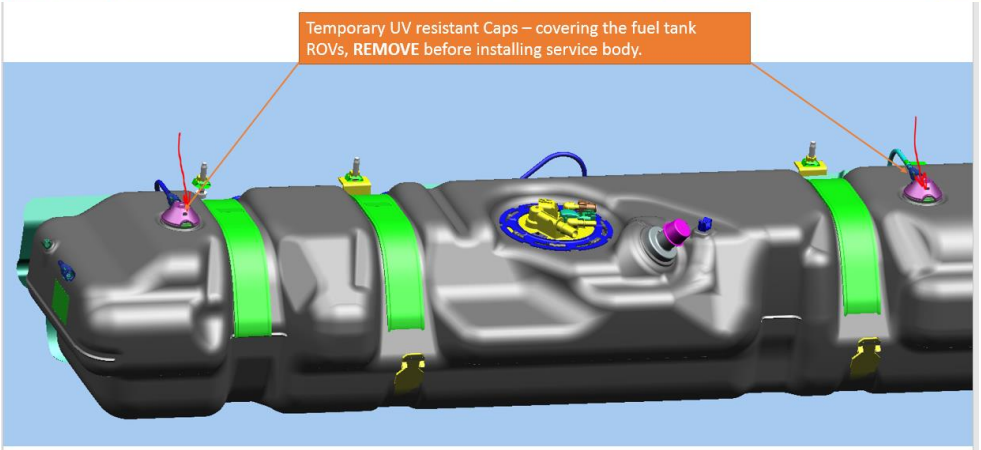
It has been determined that certain fuel tank/emission system components are sensitive to long term exposure to Ultra-Violet (UV) light. These components begin to degrade when exposed to UV light, and because of the extended exposure when stored outdoors, may lead to premature failure. To prevent damage from the long-term UV exposure on vehicles maintained in inventory outdoors, General Motors has implemented a few temporary cover/protective strategies on shipped vehicles where the fuel tank/emission system components are left uncovered following the OEM vehicle assembly process. Please refer to the examples of coverings shown below.

Upfitters are advised that, vehicles **equipped** with any of these types of temporary fuel tank component covers that removal of these coverings prior to the installation of any service bodies or boxes is **REQUIRED**. Failure to remove these covering may result in the collection of debris and possible contact/interference with fuel lines and/or electrical wiring that may cause damage to any of these components.
